Manhole Inspection Summary

Manhole # S37M__021MH

Insp Date: **10/14/08 2:00 PM**

Location Address: **battery ave**

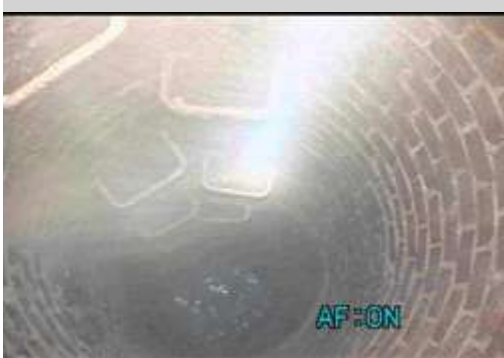
Defect 1

Count: **19** Missing: **0** ☒ **Corroded**

cor. steps

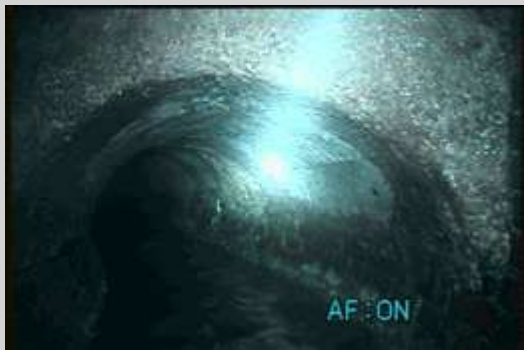
12 O'Clock Outflow

30 in. Circular Gravity Sewer
Pipe Out @ 12 O'Clock

Pipe Material: **Clay** ☐ Pipe Lined

Invert Depth: **28.50** (ft.) Flow Characteristics: **Fast**

Infiltration: **None** Pipe Seal Cond: **Unknown**

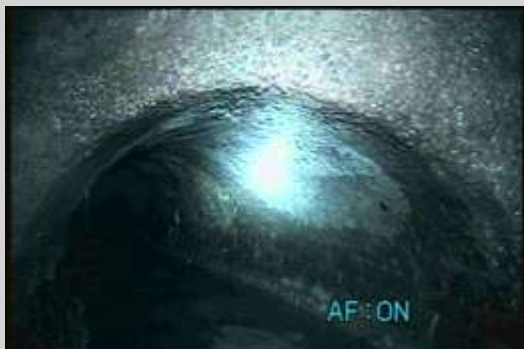
6 O'Clock Inflow

30 in. Circular Gravity Sewer
Pipe In @ 6 O'Clock

Pipe Material: **Clay** ☐ Pipe Lined

Invert Depth: **28.00** (ft.) Flow Characteristics: **Fast**

Infiltration: **None** Pipe Seal Cond: **Unknown**

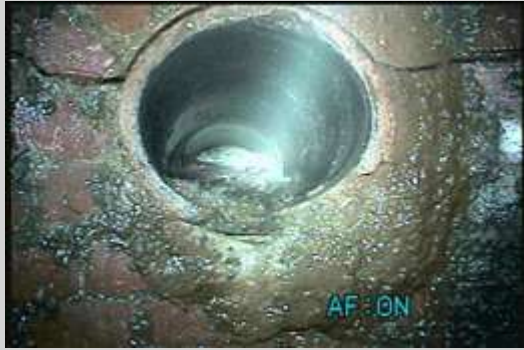
9 O'Clock Inflow

8 in. Circular Gravity Sewer

Pipe In @ 9 O'Clock

Invert Depth: **14.10** (ft.) Flow Characteristics: **Slow**

Infiltration: **None** Pipe Seal Cond: **Unknown**

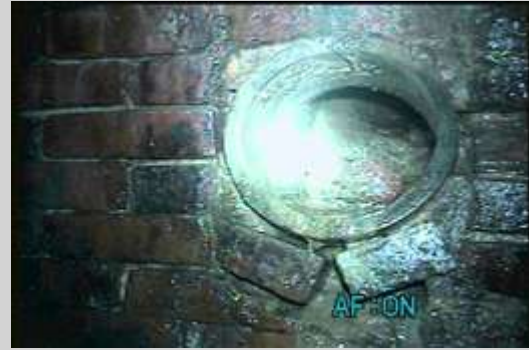
Drop In @ 9 O'Clock

Drop: **Outside Direct**

Inv Depth: **26.12** (ft.)

Drop Condition: **Open**

Connects To: **Dead End**
